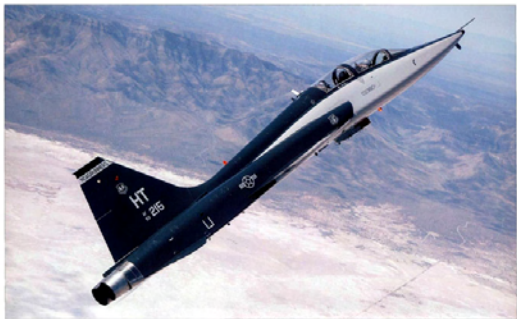
The 586th's AT-38s have an equipment bay in the spine that can house various test instruments. This example carries an unusual test fixture.
